VOL. 5 NO. 4

VICTORIA NEWSLETTER

October 1990

VICTORIA AREAS OF CONFUSION

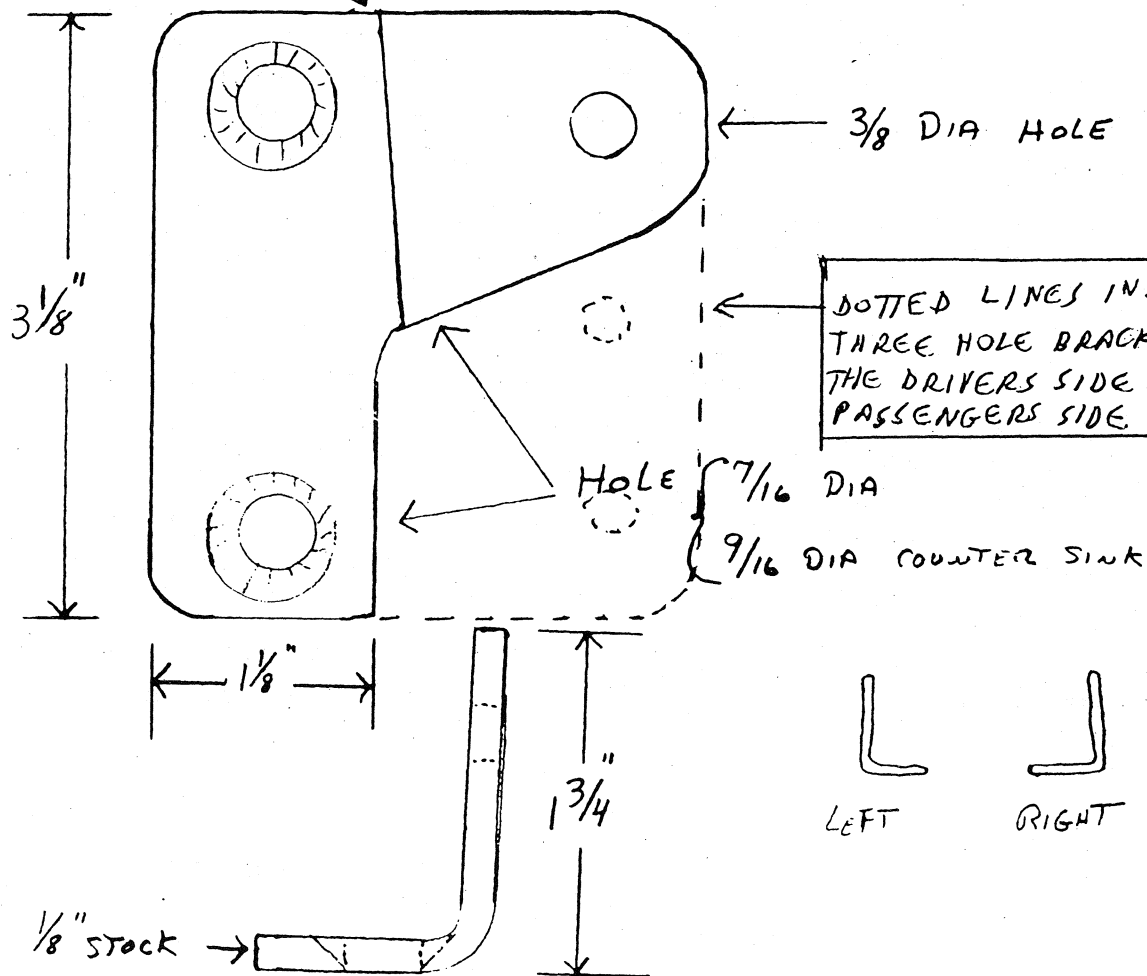
" PASSENGER SIDE SEAT BRACKET "

NOTE ANGLE
OF BEND

The seat brackets have been discussed and diagramed in previous newsletters but I will include the bracket designs in this newsletter mainly for the new members. There were the early brackets which had three holes in an angle iron type bracket. The holes were to allow the three positions fore and aft of the seat. A rod went through the hole in the left bracket, then through the tube on the bottom of the seat and then through the corresponding hole in the right bracket. The early Victorias had this bracket on both the driver and passenger seats. Later, (and we have no date on this), they came out with a one hole bracket for the passenger seat. (I assume they felt that the adjustment of this seat was not necessary or else, it was cheaper to make). As all of you know, FORD was always looking for cheaper ways to produce the cars. This may seem insignificant but over the entire car, any reductions could amount to quite a difference.

About the time the indented firewall came out in 1931, and the advent of the A 400, FORD started to install the same sliding seat of the A 400, in the Victoria. The passenger seat bracket changed to the corresponding bracket used with the sliding driver seat. This bracket was connected from two eye type bolts on the bottom front of the passenger seat bottom and connected with two corresponding eye bolts in the floor cross member. If you have any seat brackets in your Victoria other than these, you do not have the correct brackets.

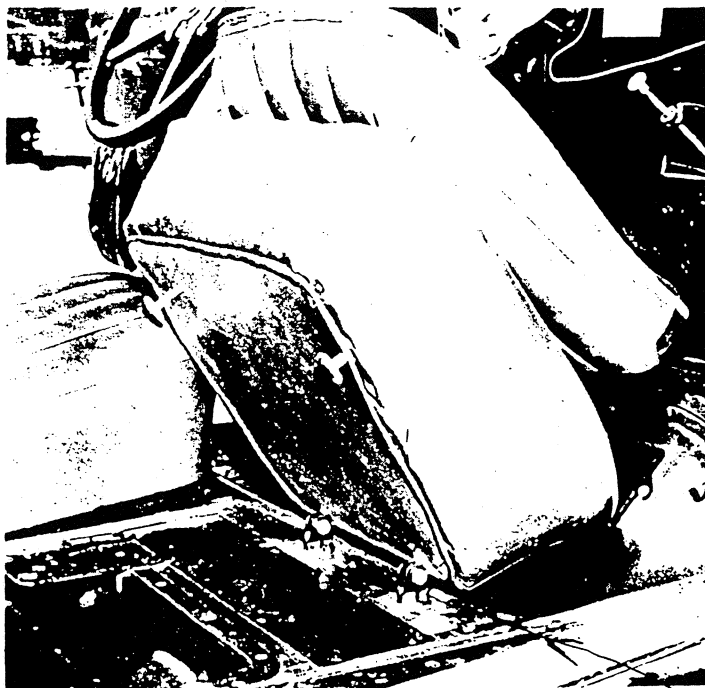
When the seat is completed, most of the structure is hidden by the upholstery. Only the hinges and support brackets are visible.

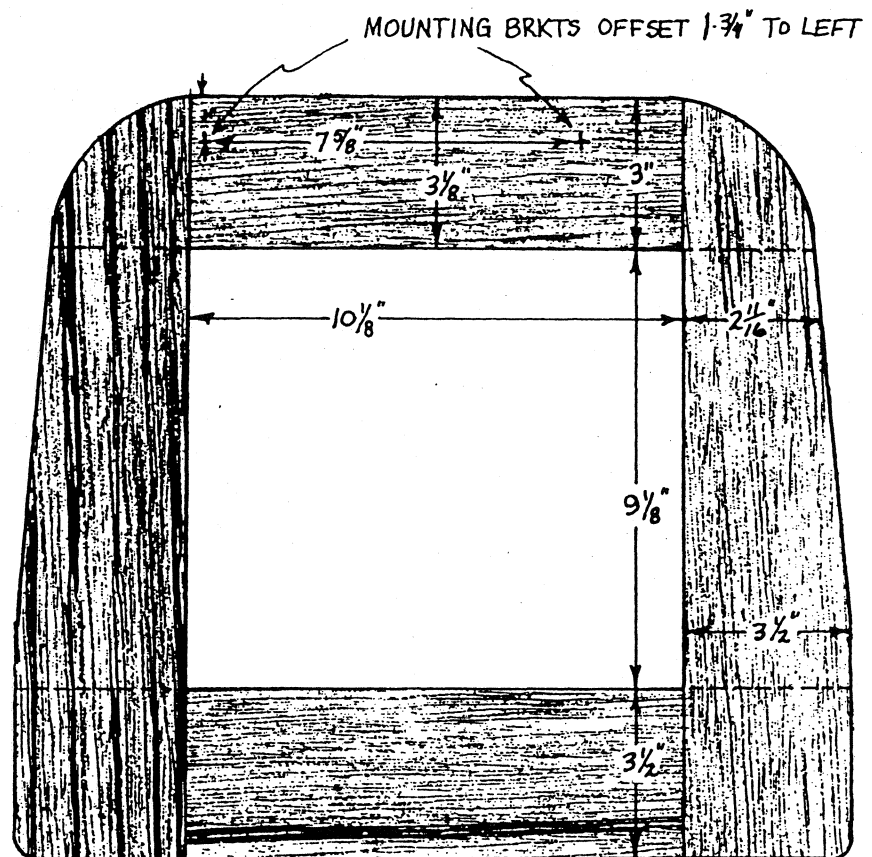
RIVETS
FOR
BACK
PANEL

SEAT BASE
(WOOD)
3/4" thick

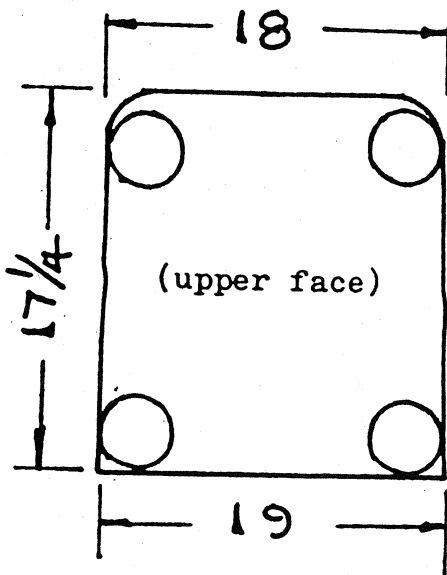
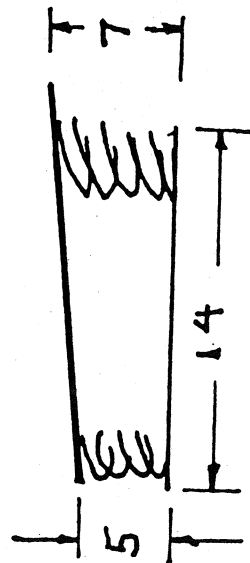
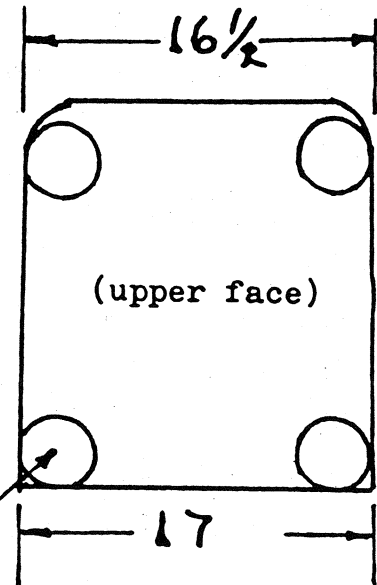
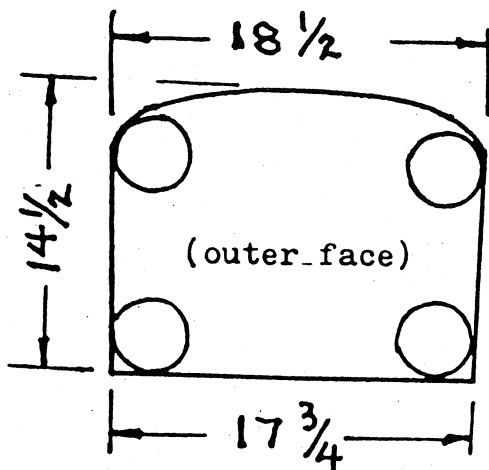
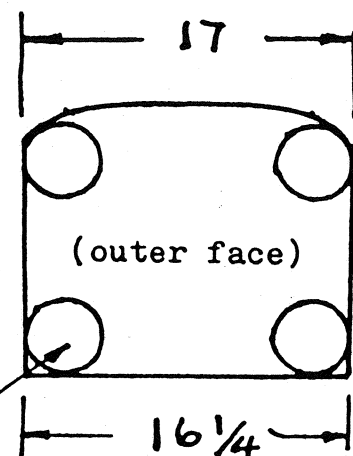
FRONT SEAT SPRING CONTOURS
EARLY VICTORIA (Nov. 1930-July 1931)

CUSHION SPRING

4 rows of 4 springs
3 3/4 diam. coils

BACK-REST SPRING

3 rows of 4 springs
3 3/4 diam. coils

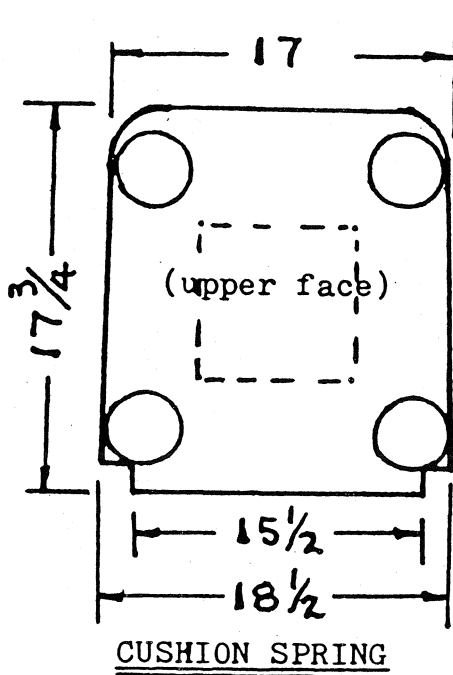
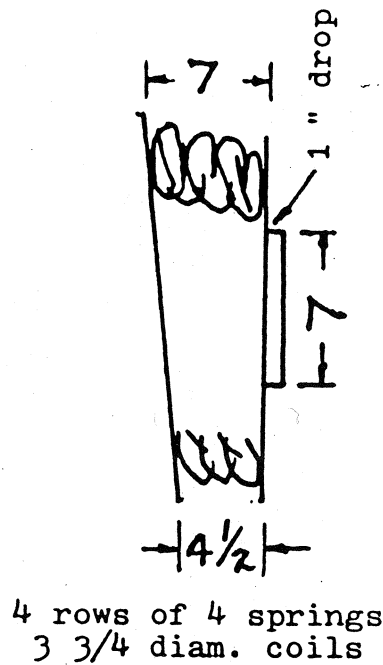
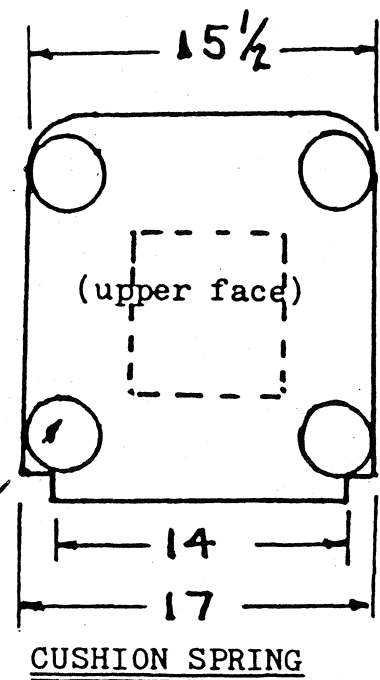
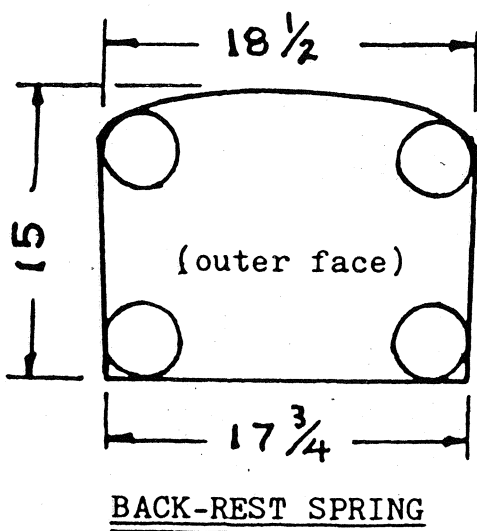
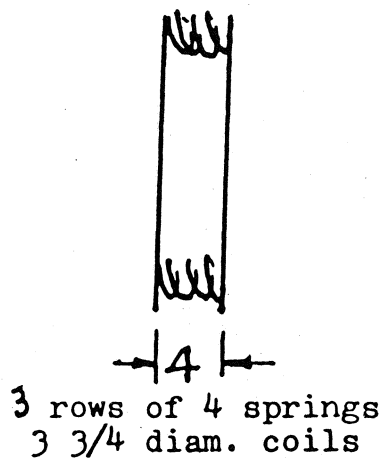
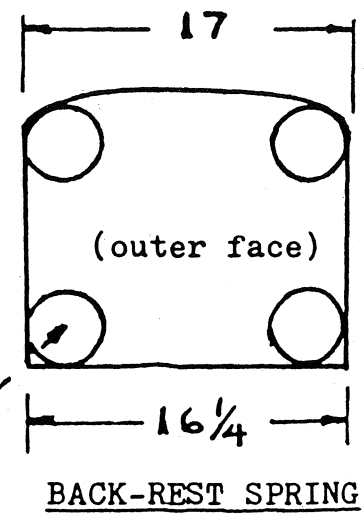
FRONT SEAT SPRING CONTOURS

LATE VICTORIA (JULY-DEC. 1931)
(also 400A Convertible Sedan)

DRIVER'S SIDE

PASSENGER'S SIDE

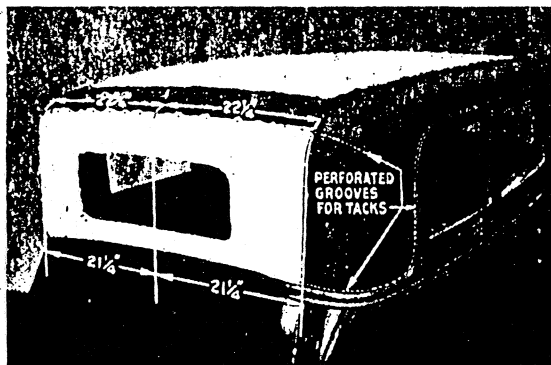
Fig. 1050

Both bottom corners of top deck are next attached, using two 12 oz. tacks at each corner, and lining up the curtain with the markings. Make certain that both tacks go through the 3 layers of cloth at the seam so as to stand the pull when stretching top into place. All tacks must be placed in the perforated grooves so that the binding will cover the tacks. (See Fig. 1050.) Next tack the

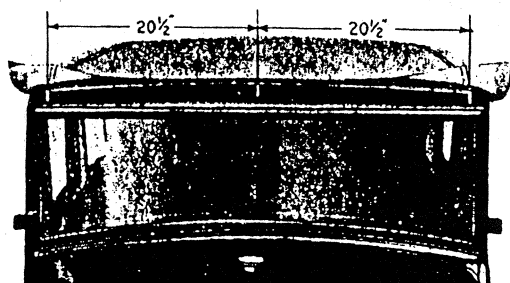
Fig. 1053

body and measure $20\frac{1}{2}$ " on each side of center line and mark body at that point. (See Fig. 1053.) Next line up the seams in the top deck with these markings and pull forward on both front corners (one corner at a time) until all wrinkles are smoothed out, then tack the corners down with two 12 oz. tacks. The seams must follow the contour of the roof.

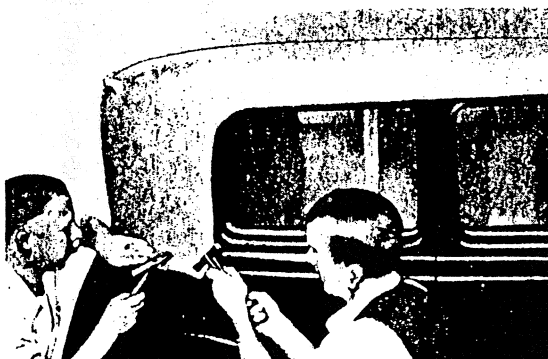
Fig. 1054

at outer corners. (See Fig. 1054.) Both rear quarters are tacked down in this manner.

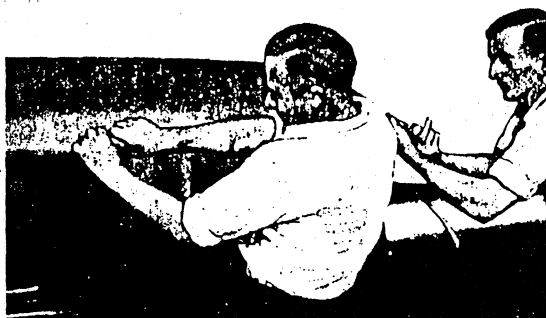
Fig. 1055

top deck must be drawn down very tightly when performing this operation. (See Fig. 1055.) Then tack down with four 6 oz. tacks along

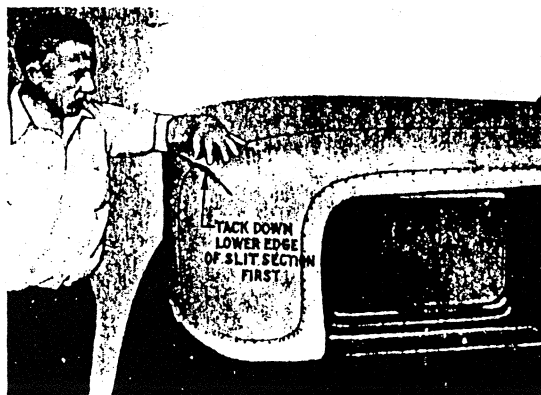
Fig. 1056

Next tack down the upper edge in the same way. (See Fig. 1056.) Tacks must be very close together at these corners. (See Fig. 1057.)

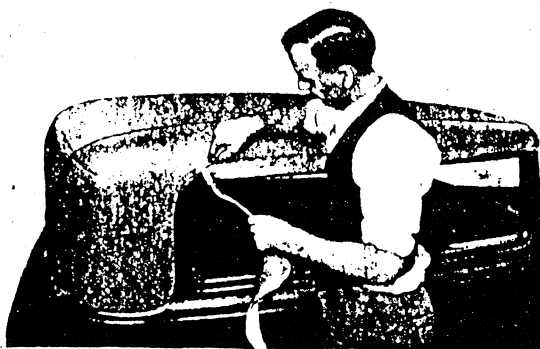
Fig. 1058

Trim off surplus stock all the way around the tacked section, trimming as closely to the tacks as possible. (See Fig. 1058.) Next tack down the front end of the top deck, starting at the center and working outward. (See Fig. 1059.) Do not trim off surplus stock at front end until after moulding is installed.

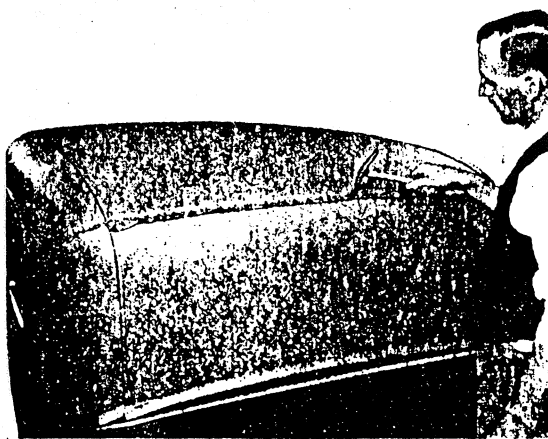
Fig. 1060

Stretch rear end of top deck towards rear and tack down as shown in Fig. 1060, then trim off surplus stock close to the edge of the tacks.

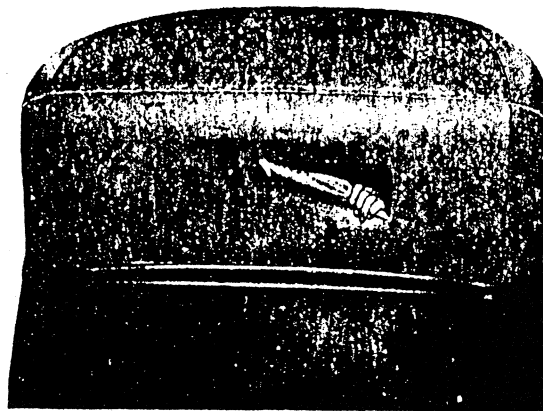
Fig. 1061

The back window is next cut out, leaving about $1\frac{1}{2}$ " of stock all the way around the edge of the back window. A sharp knife is used for performing this operation. (See Figs. 1061 and 1062.)

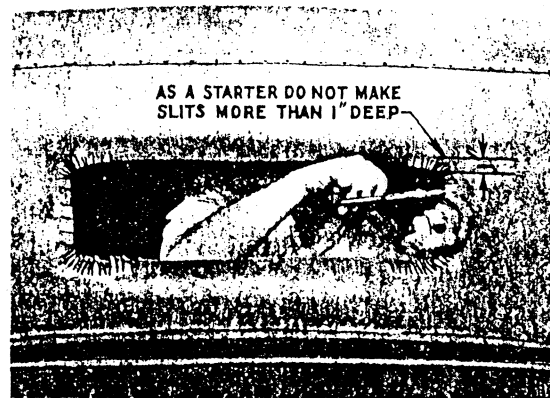
Fig. 1063

the corners the slits should not be over $\frac{1}{4}$ " apart and as a starter they should not be over 1" deep. (See Fig. 1063.) This operation is very important. If not correctly performed, it will necessitate replacement of the deck. If necessary to lengthen the slot when tacking down,

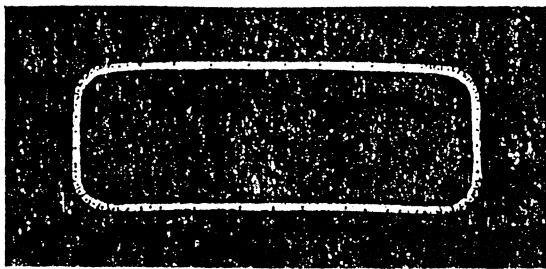
Fig. 1064

use a knife. These slits must not show from the outside after back window is tacked in. Figure 1064 shows back window tacked in place.

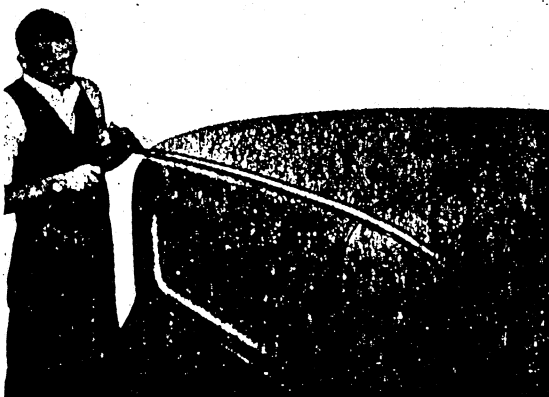
Fig. 1066

lower seam on binding with tacks already installed. Position the binding about $\frac{1}{4}$ " back from end of groove. (See Fig. 1066.) Place several tacks in binding, then stretch tight and tack opposite sides of binding as shown in Fig. 1066. Next fold the binding

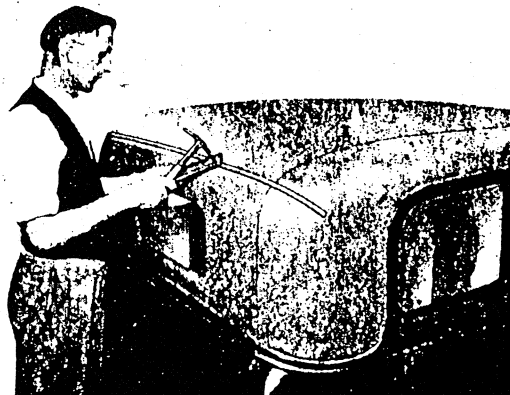
Fig. 1067

over and press it down tightly until a smooth surface is obtained. A hammer and fibre or hardwood block are used for this purpose. (See Fig. 1067.) Binding clip A-192140 is then placed at each end of binding. (See Fig. 1068.)

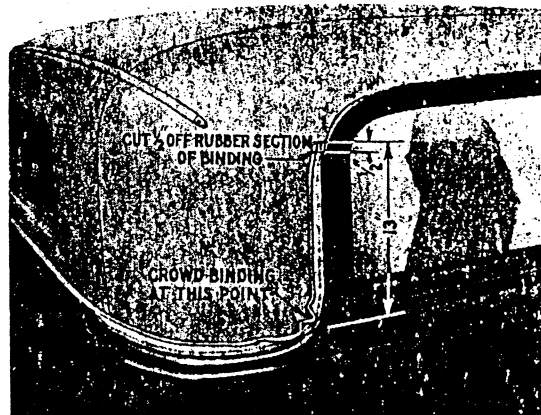
Fig. 1068

Next install lower binding. Locate correct position—measure 13" from upper moulding. (See Fig. 1068.) Then peel back binding and cut off $\frac{1}{2}$ " of the rubber section of the binding to allow end of drip moulding to fit down snugly

Next install drip moulding retainer. Place moulding retainer in position on 12½" mark on binding. (See Fig. 1068.) See that lower edge of retainer is flush against the upper edge of door header. Then nail retainer in place,

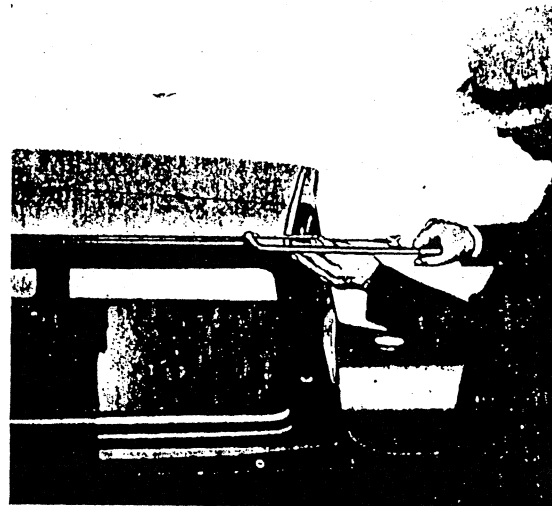
Fig. 1073

Cut out ends of roof moulding about $\frac{1}{16}$ " above drip moulding to prevent any possibility of squeak a hack saw is used for this purpose. (See Fig. 1073.) The moulding should then be filed down and sanded from seam in the top deck down to the drip moulding. (See Fig. 1074.)

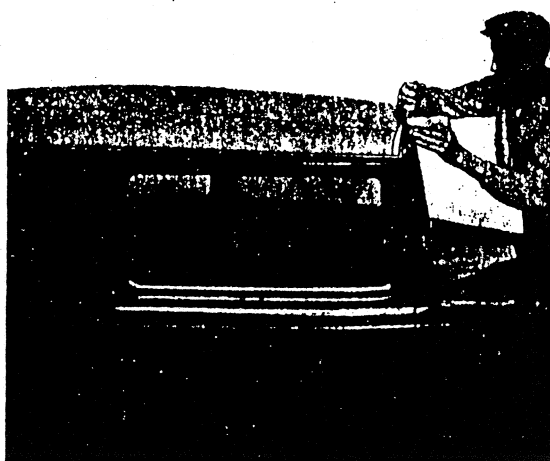
Fig. 1075

Next trim off the surplus top deck material as close to the moulding as possible. (See Fig. 1075.) Use a sharp knife to prevent ragged edges. Next seal the edges of the front roof moulding from seam to seam (see Fig. 1076), also seal rear upper binding in the same way. (See Fig. 1077.) The sealing fluid in seam should be about $\frac{3}{8}$ " wide. A special sealing fluid is used for this purpose. The fluid can be obtained direct from the Dolphin Paint and Varnish Co., Toledo, Ohio. It is put up in both large and small cans. Fig. 1078 shows the completed job.

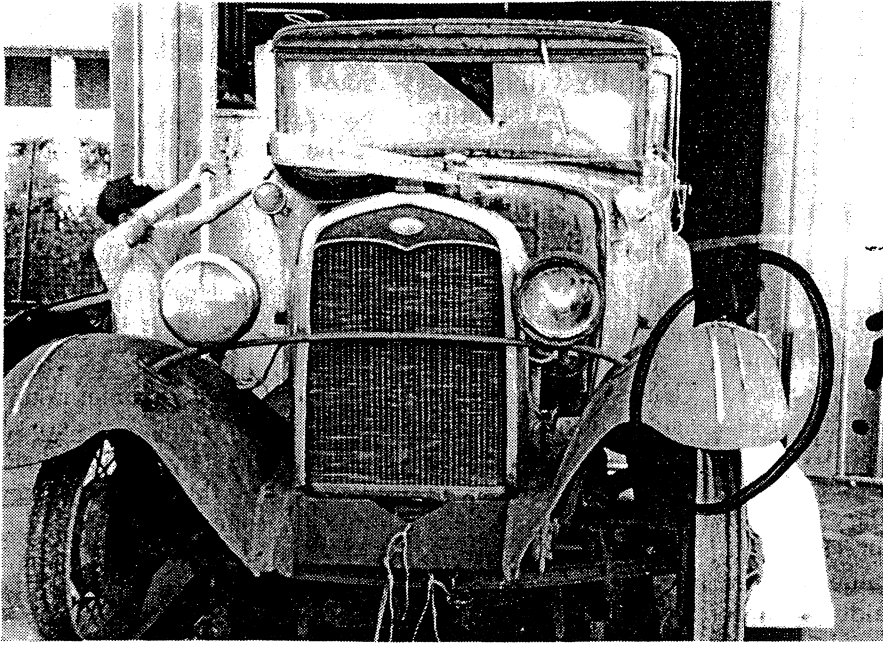
Mr. Rod Mc McMullin of Brisbane, Australia is a new member and has sent photos and questions about his new Victoria. At the left, you will see the car with strips on the fenders. No, Rod, the strips are not original. He also asks if it is a Murray or Briggs. Since we have never found a Briggs Victoria, we can assume that it is a Murray. By the way, the headlight buckets and lenses appear to be V-8 not Model A.

This car has quite an air filter on it. Don't know what it is from but it is not Model A.

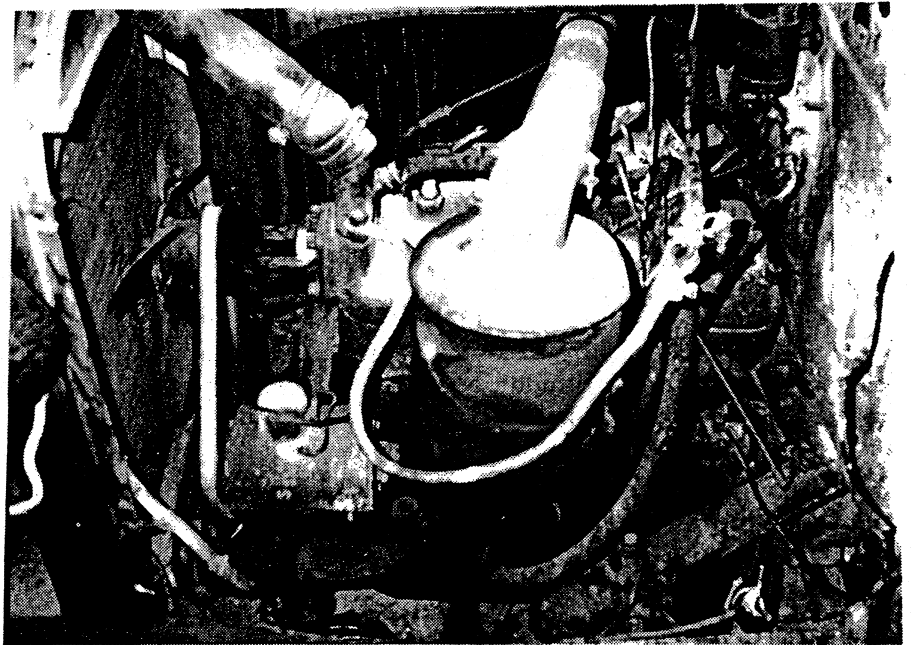
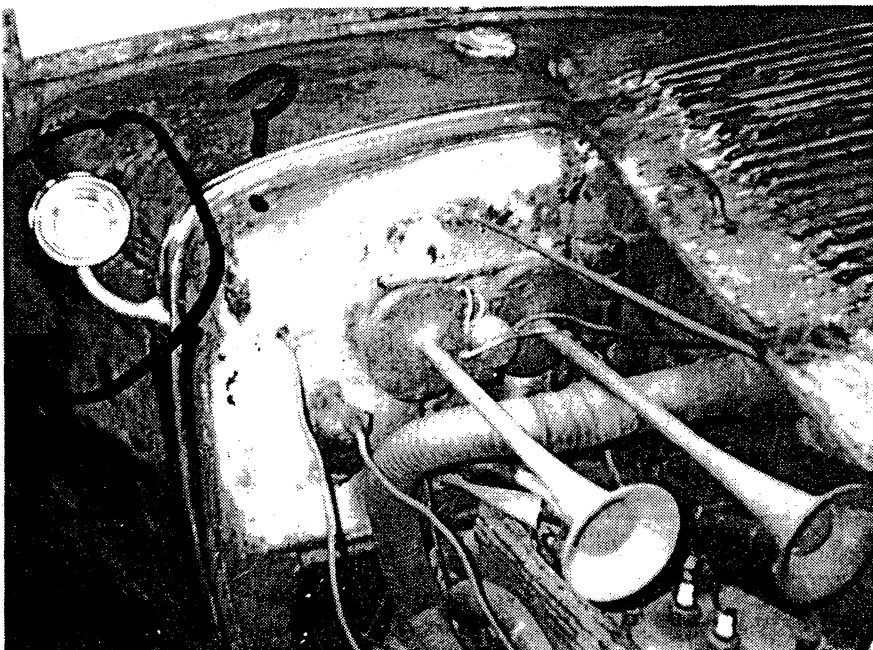
This Victoria came from Canada and has a Canadian engine number which was August, September of 1930. The Cowl Lights are original but the lenses are not Model A. Note the horns on this car which are not original.

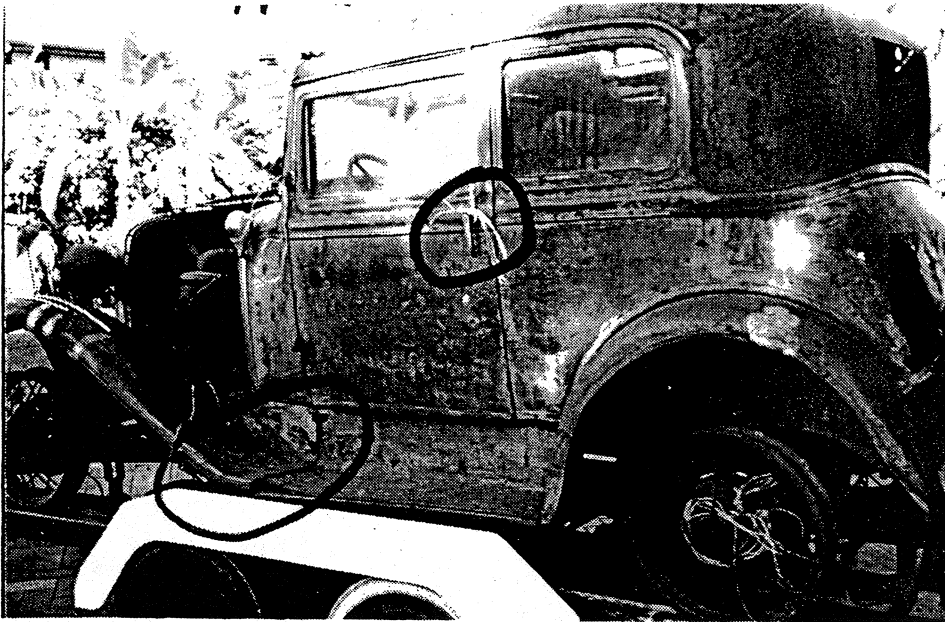
This photo shows that the Victoria does not have original door handles outside. The inside shots show they are not original either. You will notice that this car has a 1931 Radiator but the splash aprons and fenders are 1930. We all know that the Victorias were supposed to be 1931 but Ford used up his stock and this is an example by having the 30 parts mixed with the 1931.

I have really studied the interior shot to try to determine if the door and window handles are original. While they look similar, I think they may be V-8 Just look at that heater. While it is not original it might be worth restoring and using in the winter.

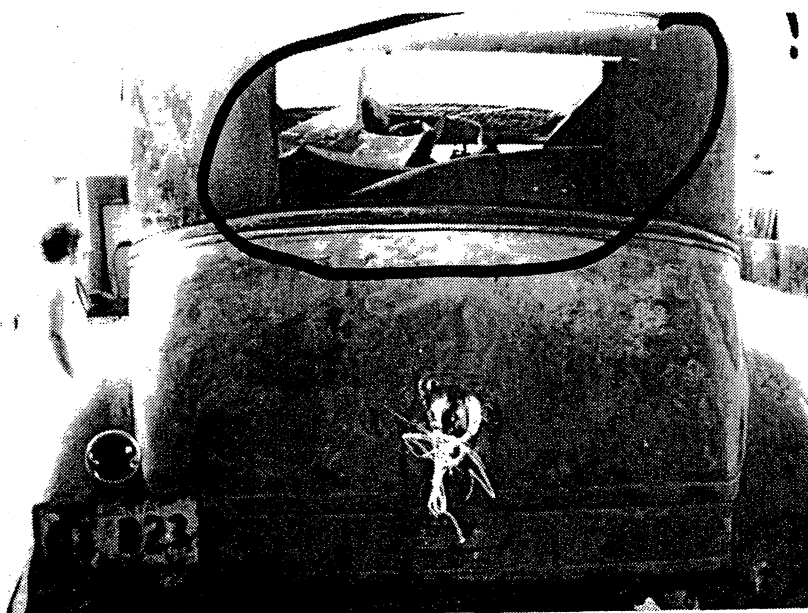
This rear view shows the Victoria with Alberta, Canada license plates. All of the rear window wood is missing as well as the window frames. If any of you have the rear window items for sale, please write to Rod McMullin, 29 Eagle St., Victoria Point 4165, Brisbane. Queensland. Australia.
